# East Pond Data 2008

## 2008 East Pond Secchi

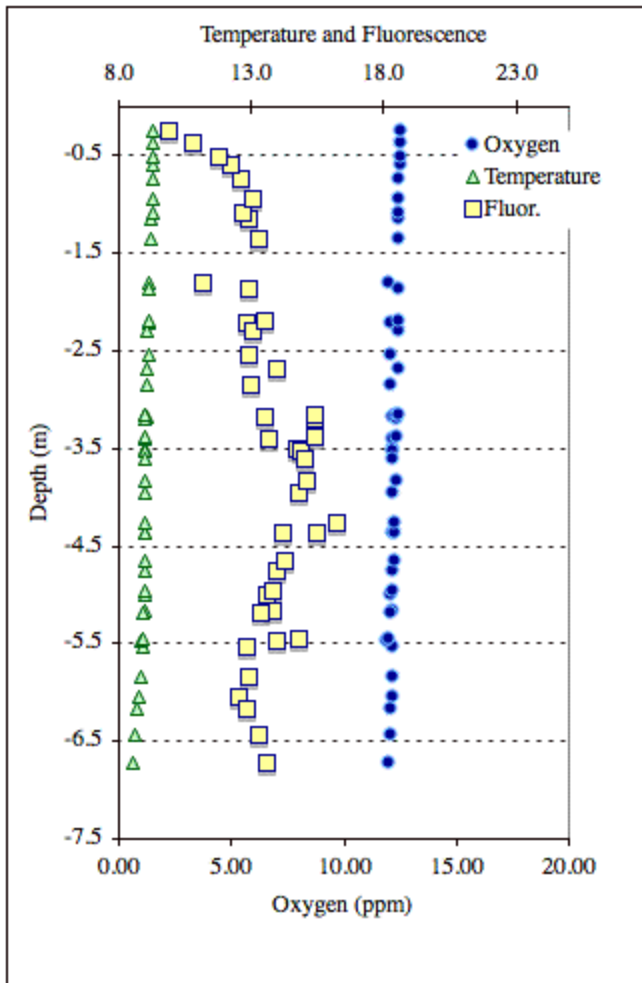
On 5/3 East Pond is well mixed from top to bottom as illustrated by the uniform temperature and oxygen profiles shown below. The fluorescence is high in the lake, consistent with the shallow Secchi depth. The lake is relatively cold, but could warm up quickly with a few warm, sunny days. Given the shallow Secchi depth, we expect most of the warming to occur in the top 2-3 meters. Significant rain or wind events will distribute the heat deeper in the lake.

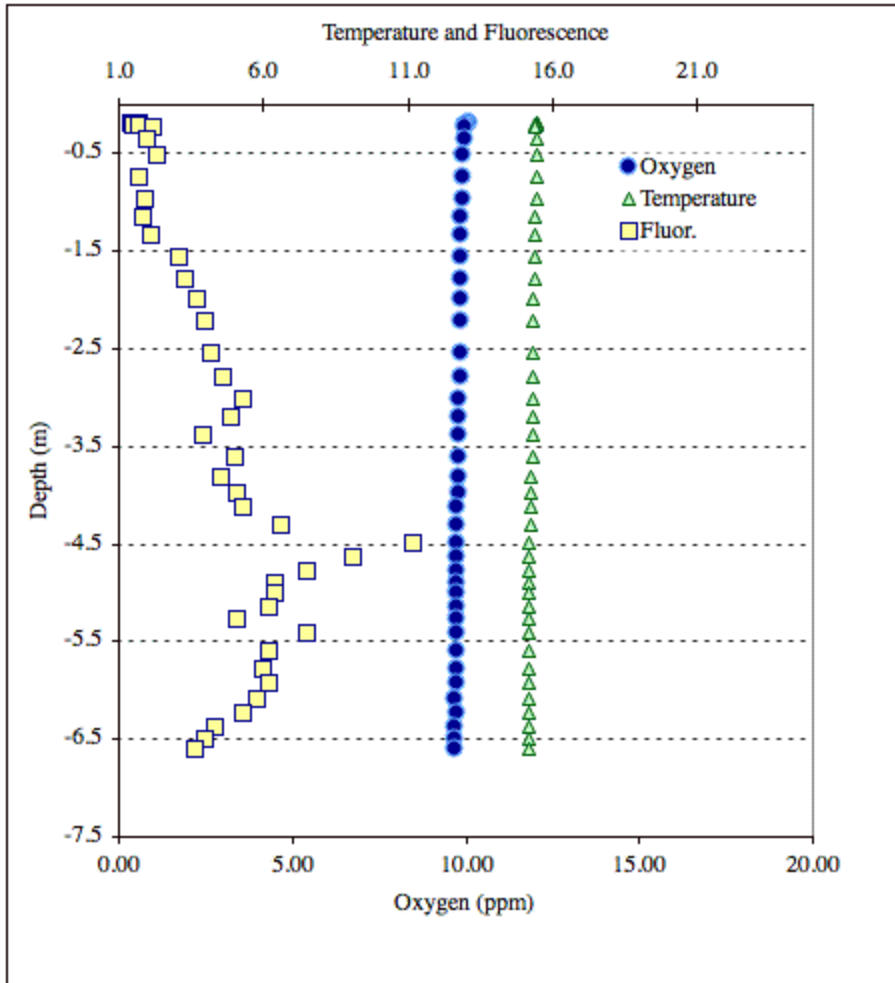
On 5/22 East Pond and North Ponds are mixed at 15 oC. The Secchi depth in East Pond has deepened by almost two meters to 5.4 meters in the last 8 days. This deepening is consistent with the fluorescence profile that shows significantly less chlorophyll above 4.5 meters.

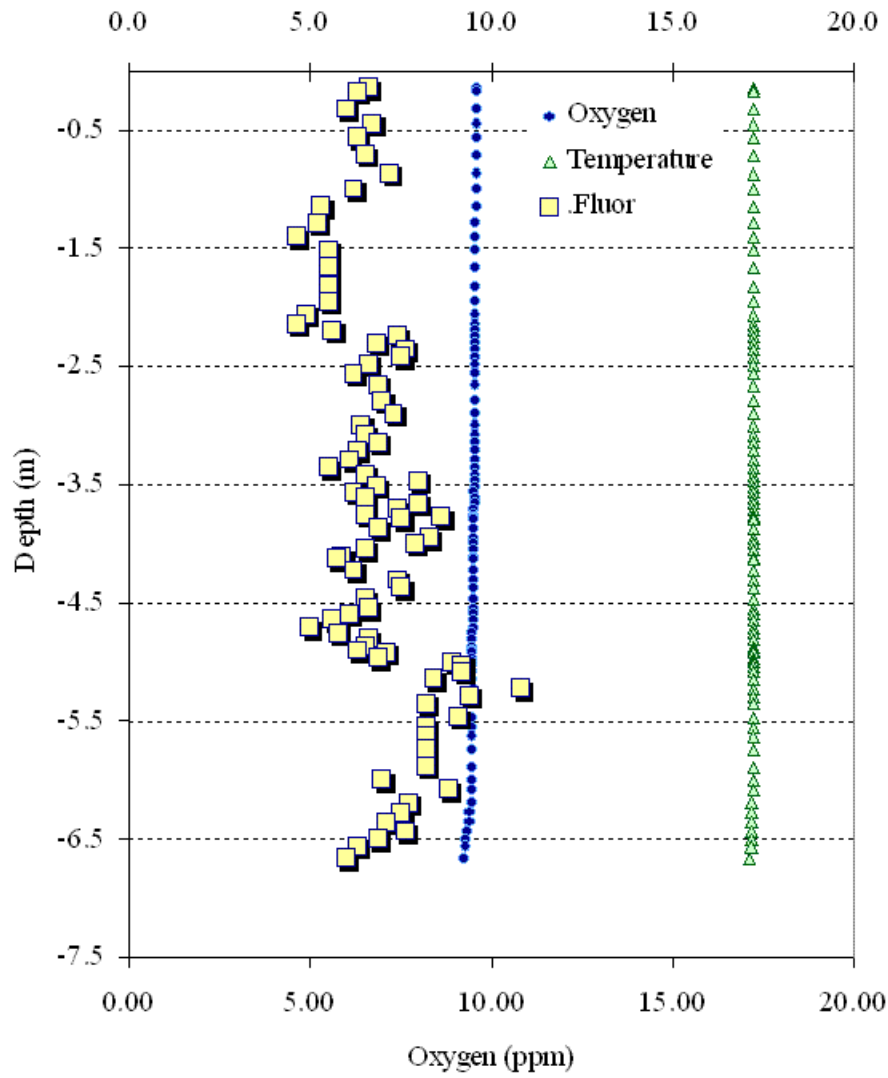
### Temperature and Fluorescence

On 6/6/2008 East Pond and North Ponds are mixed at 17 oC. The Secchi depth in East Pond is shallower again with a depth of 2.5 meters. The lake is experiencing a moderate bloom as illustrated by the uniform fluorescence profile. Oxygen concentrations remain at saturation throughout the water column.

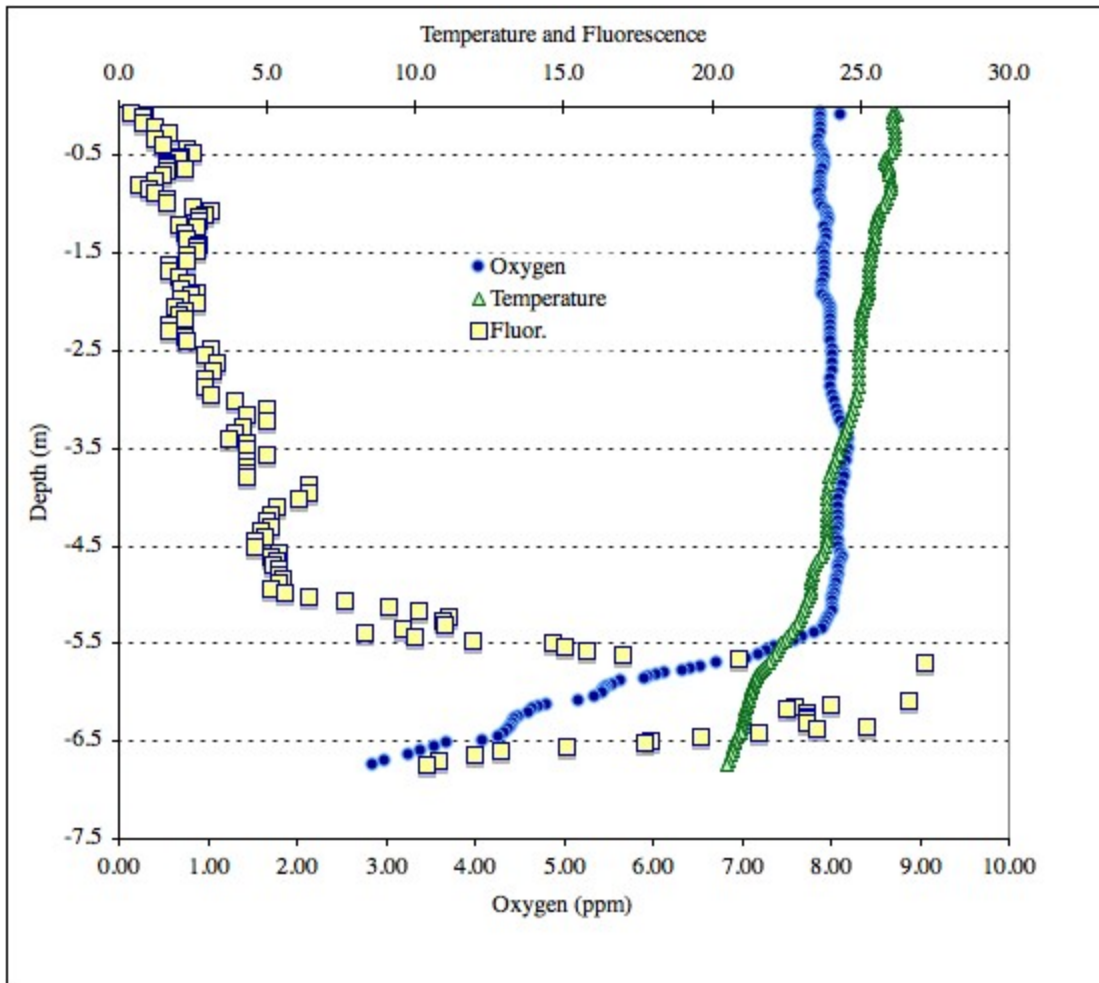
Colby A

The Secchi depth decreased nearly a meter at both stations. The lake is now becoming stratified at 5.5 meters.
